Re: ArcelorMittal USA Material Safety Data Sheets,
Section 313 of Emergency Planning and Community Right-to-Know”, and
Cautionary Notes about Removal of Straps/Bands from Steel Coils.

CAUTIONARY NOTE ABOUT REMOVAL OF STRAPS FROM STEEL COILS

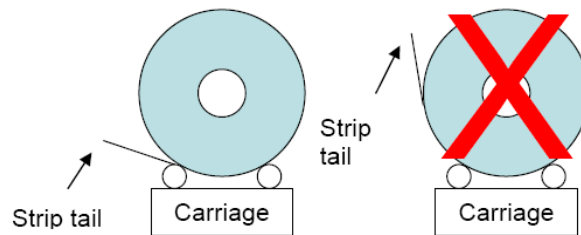
The potential for elastic springback increases with increased strip thickness, increased yield strength, and decreased coil outside diameter. The best means of preventing elastic springback is to place the coil end as low as possible under the coil – where the coil end is fully retained by the weight of the coil.
